NATIONAL TRANSPORTATION SAFETY BOARD

AIRCRAFT ACCIDENT REPORT

**SIERRA PACIFIC AIRLINES
deHAVILLAND DHC-6-300, N361V
HAILEY, IDAHO
FEBRUARY 15, 1983**

NTSB/AAR-84/03

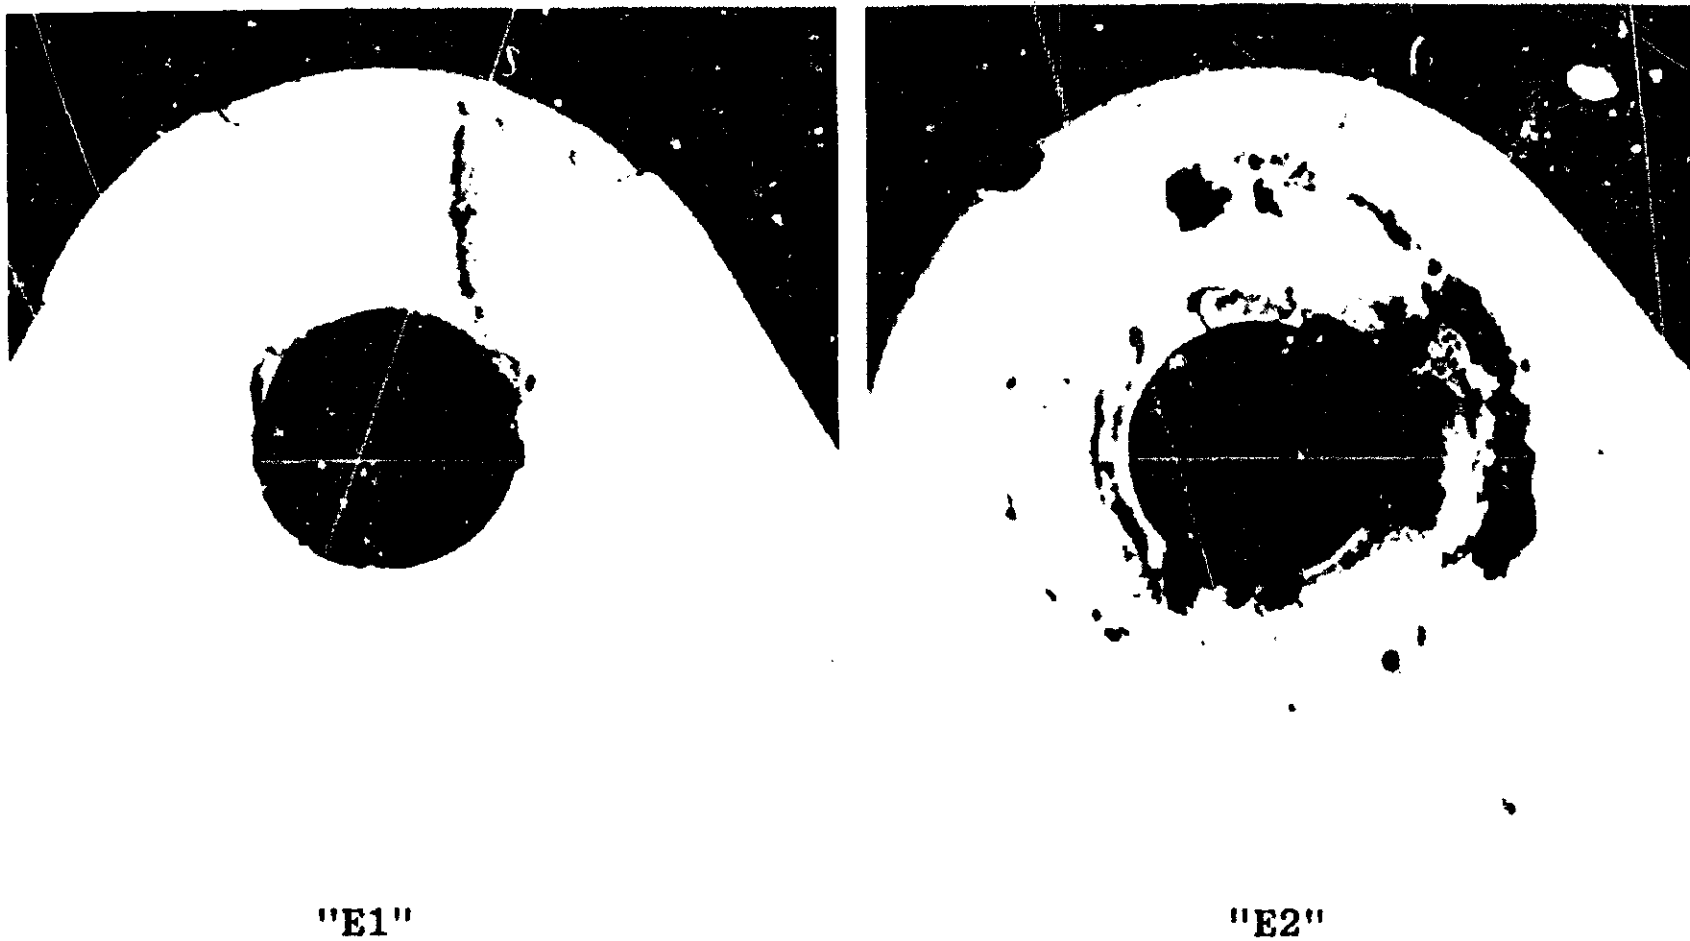
Figure 9 shows closeup views of the outer surfaces of the clevis ears. The left photograph in figure 9 shows no scratch marks on the painted outboard surface of the left clevis ear from the presence of a nut, washer, or bolt head. (Missing paint above the bolt hole indicated that the elevator had been suspended when it was painted.) The outboard surface of the right clevis ear, shown in the right photograph in figure 9, had marks in and on the painted surface, indicating that a washer, nut, or bolt head had contacted this surface.

Figure 9.--Left photograph ("E1") shows the outboard surface of the left ear (side not visible on inspection), and the right photograph ("E2") displays the outboard surface of the right ear (visible side). Both photographs X4.

From the available evidence, the Safety Board could not determine who installed an improper bolt in the elevator control rod or exactly when the installation occurred. The outboard surface of the left clevis ear showed no scratch marks, but the 6-minute test flight should have left some rub marks, however slight, from a properly secured control rod. This indicates that the control rod was not properly secured when it was installed after the second AD inspection. Maintenance performed by Western Aircraft did not involve the removal of control rods and can be eliminated as a factor. Therefore, the Safety Board concludes that a breakdown in Sierra Pacific's inspection procedures occurred during the second and third AD inspections and that a poorly performed inspection failed to detect the presence of a nonstandard bolt in the connection.

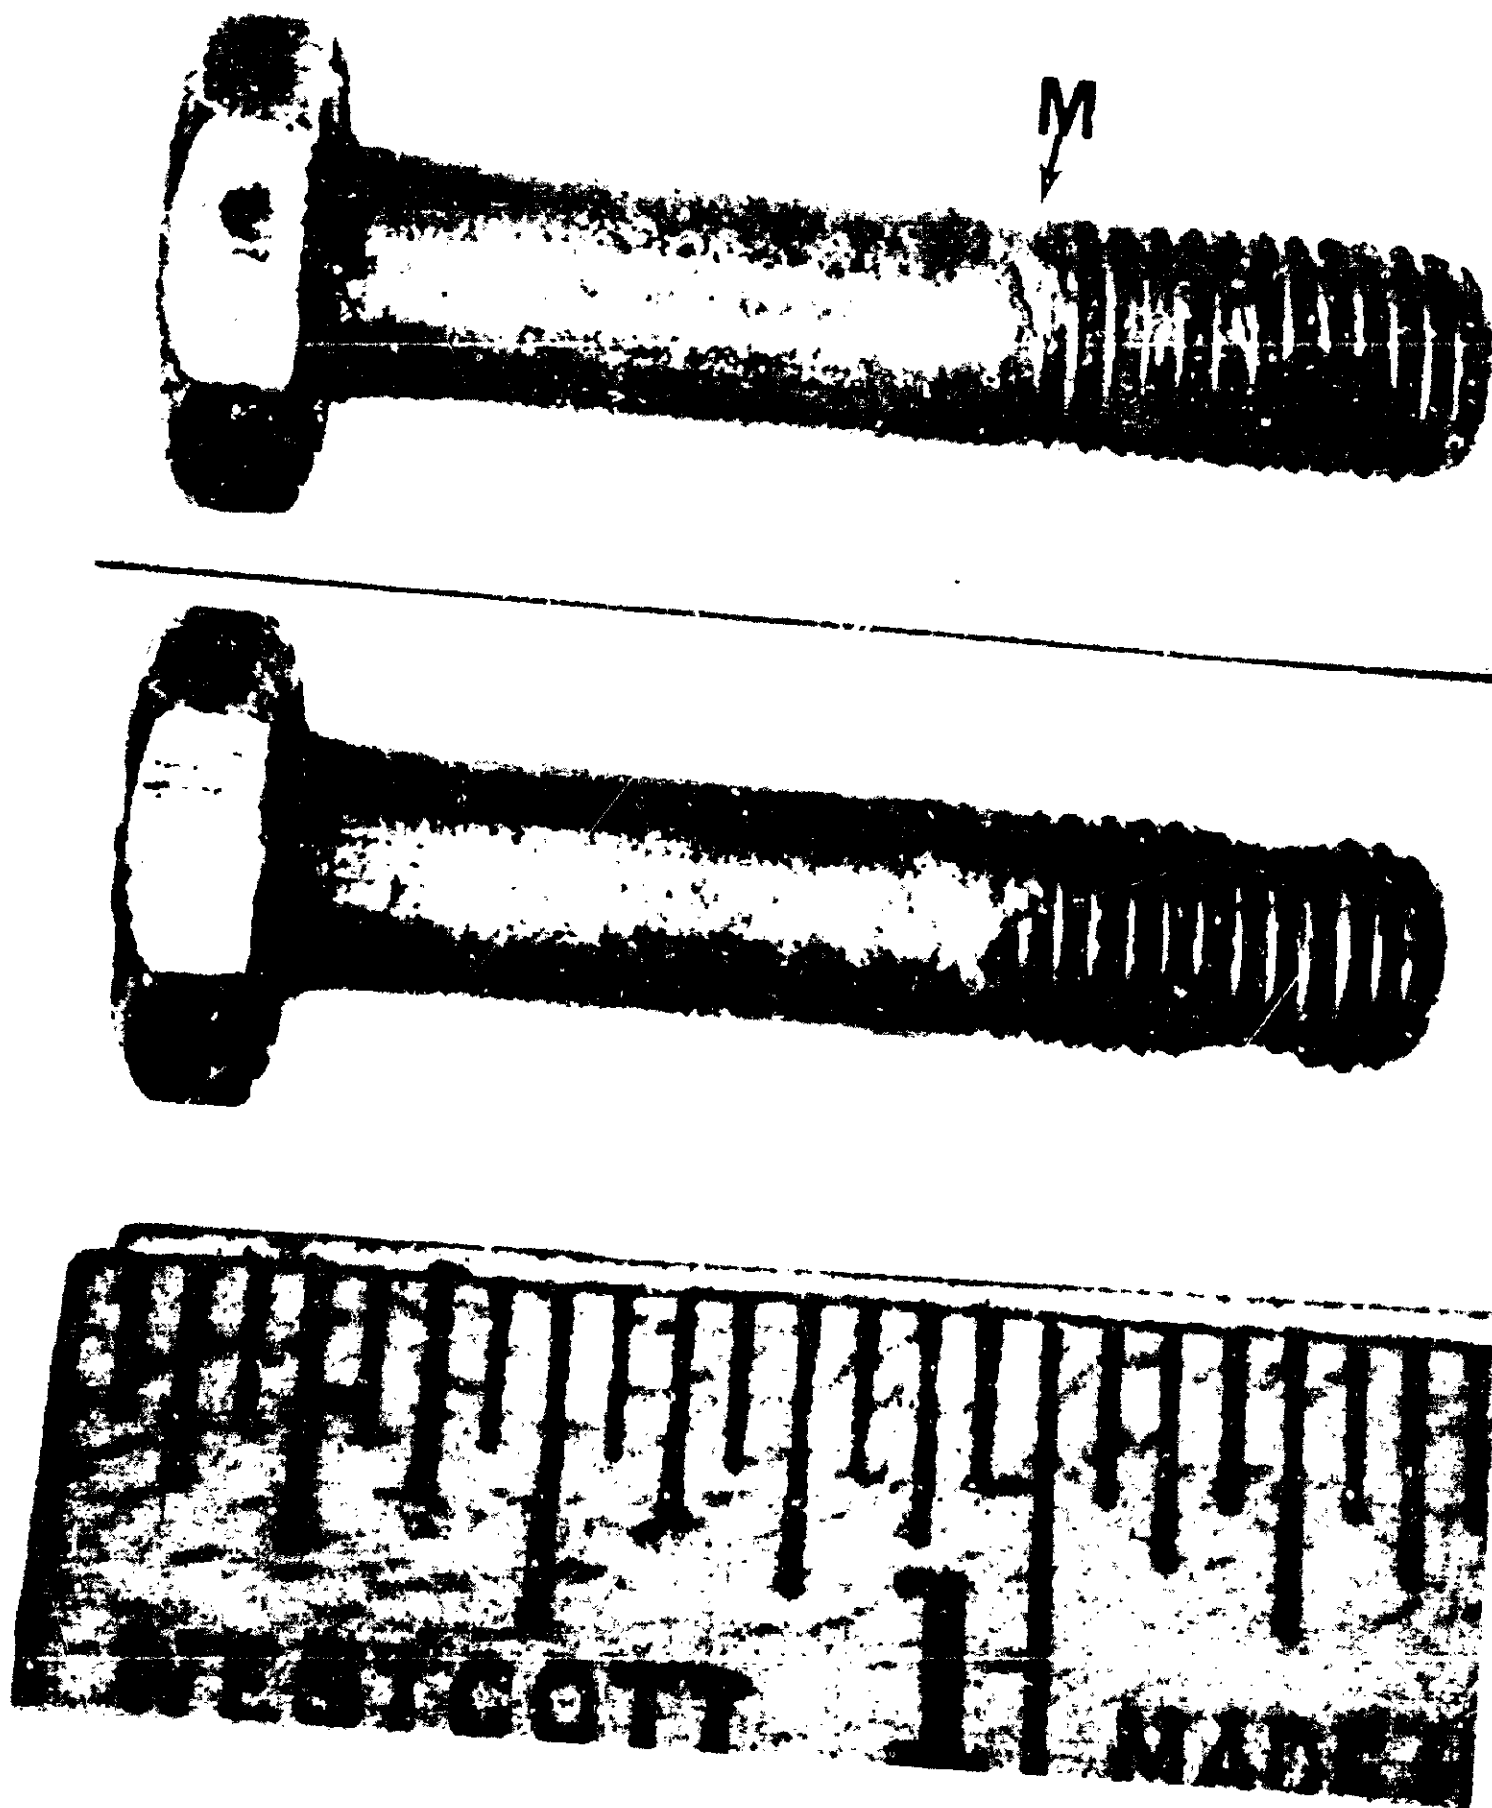
Bolt Found in Empennage.--Figure 11 shows two views of the bolt found loose in the empennage area. The bottom view shows the bolt rotated about 45° relative to the top view. The overall length of the bolt from the underside of the head measured 1.16 inches, and the diameter of the shank was 0.245 inch. An AN 174-12 bolt is 0.2487 to 0.2492 inches in diameter by about 1.27 to 1.31 inches in length. Arrow "M" in figure 11 shows an area of the bolt with metal apparently smeared onto the bolt. Figure 12 shows this area in greater detail.

Figure 11.--Two views of the bolt that was found in the empennage.
"M" indicates a metal smear.

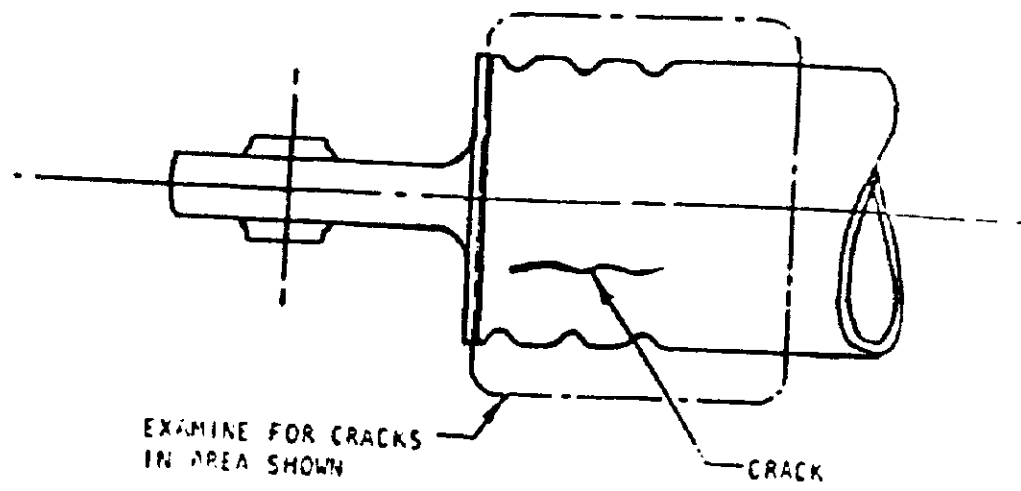
TYPICAL TUBE WITHOUT SLEEVE

ANY CRACK WITHIN THE INSPECTION AREA SHOWN IS REASON FOR REJECTION OF ROD.

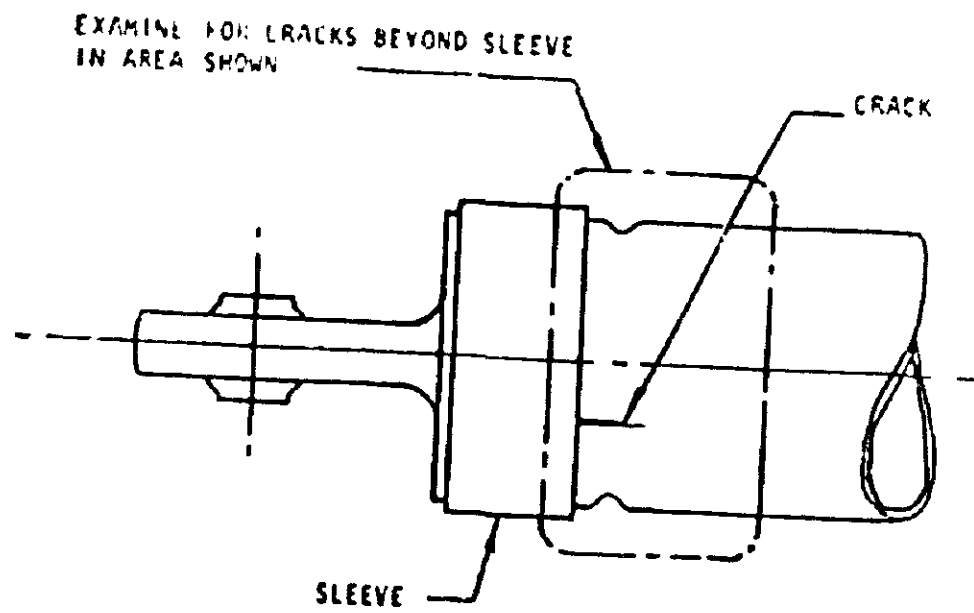
TYPICAL TUBE WITH SLEEVE

INSPECT FOR POSITION AND SECURITY
